Mangarara

SUB-CATCHMENT PLAN: SUMMARY

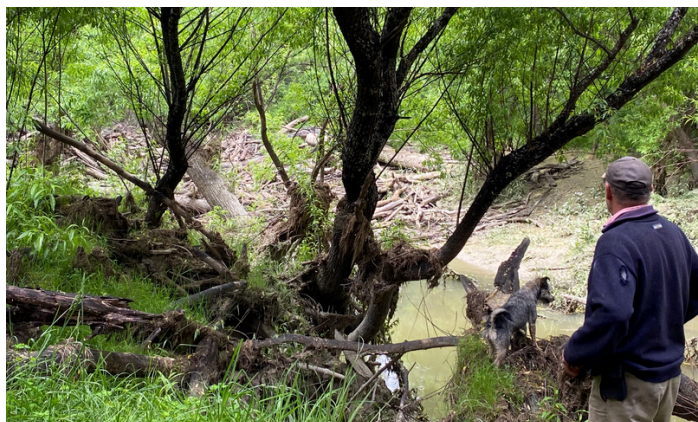
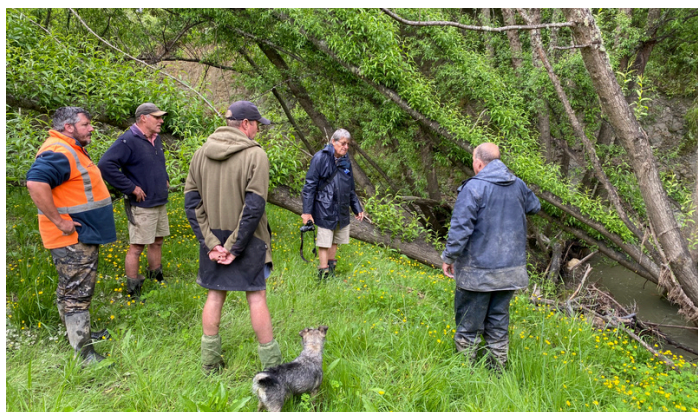
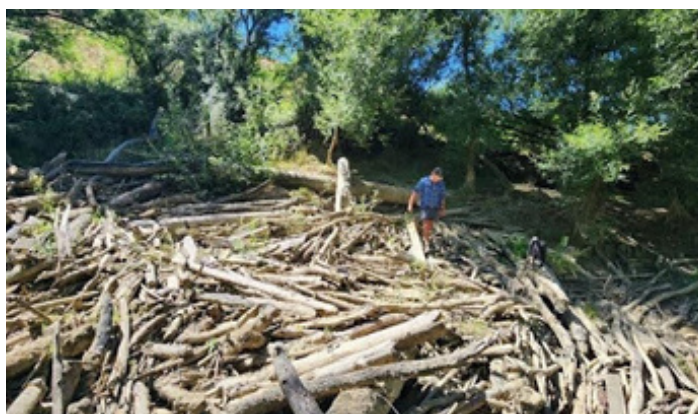
In the Mangarara catchment, aging crack willows are breaking apart, drifting downstream, and clogging the river. Large willows dominate extensive sections of the riparian zone, exacerbating erosion and flooding risks. Observations from field visits indicate that past removal efforts have been effective, with treated streambanks remaining stable over extended periods.

The Mangarara Stream is significantly affected by crack willow, an invasive species that obstructs waterways, accelerates bank erosion, and increases flood risk. While it does not produce seed in New Zealand, its brittle branches readily take root, enabling rapid colonisation of bare sites downstream.
