# Kahahakuri Erosion and Cow Cress Mitigations

Prepared by A/Prof. Ranvir Singh (Environmental Hydrology & Soil Science) and Prof. Ian Fuller (Physical Geography) at the School of Agriculture and Environment, Massey University

Prepared for the Tukituki Land Care (TLC) group, Hawkes Bay

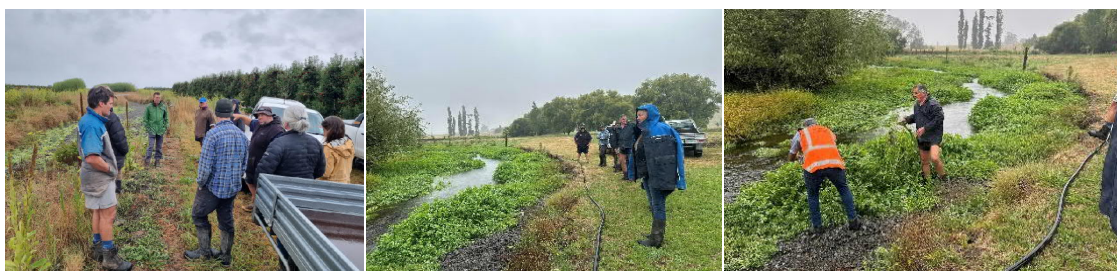
Photo 1: Kahahakuri field visit and sites assessment (February 2024). *Photos: Courtesy TLC Communication Coordinator.*

Cow cress 'water celery' spread appears abundant in the visited drains and stream in middle and lower parts of the Kahahakuri catchment. Cow cress favours nutrient-rich environments, therefore Ranvir took some stream and drain water samples for their testing of nitrate levels. The stream channel erosion appears more severe in upper and middle lengths of the stream, where reworking or erosion of the secondary sediment stores in the bed and banks (floodplain) is active during high flow events.

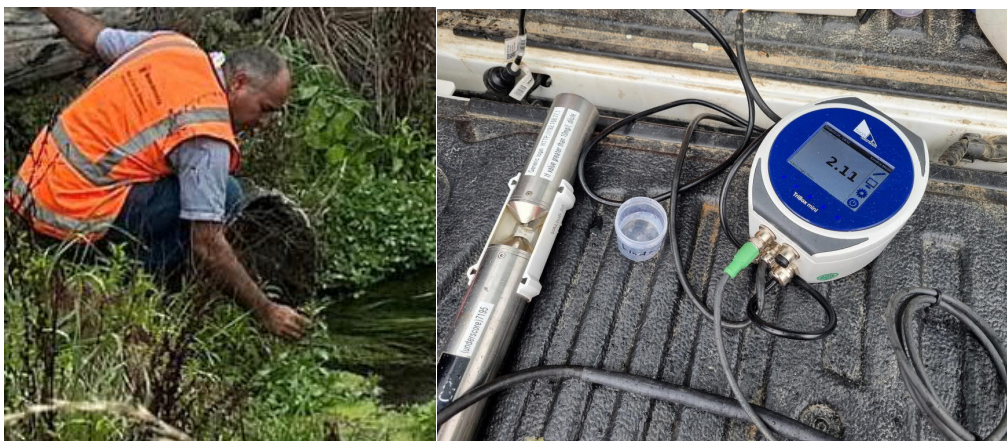
*Photo 3: Ranvir Singh (Massey University) taking a drain water sample and demonstrating its testing for nitrate-nitrogen during the field visit (Feb 2024).*

Ranvir took a few on-spot water quality samples during the field visit (Photo 3) and later collated and analysed long-term monthly water quality data (from 2011 to 2022) at the Kahahakuri stream u/s Tukituki River (Data Source: LAWA <https://www.lawa.org.nz/>, accessed in April 2024). HBRC representative also shared the results of their water quality survey conducted in 2015/16 across the Kahahakuri catchment. A preliminary analysis of this collated water quality data clearly highlights the elevated concentrations of dissolved reactive phosphorus and inorganic nitrogen, and nitrate-nitrogen as a main form of dissolved inorganic nitrogen in waterways the Kahahakuri catchment.
